ITEM: BEARING PADS

FINDING: Bearing pad mating surfaces worn down

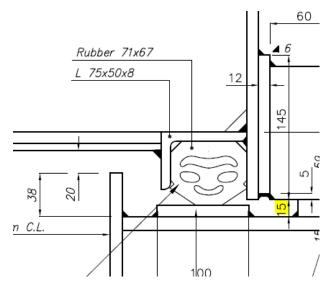
ISSUE WHEN PADS ARE WORN / PANEL TO COAMING DISTANCE IS REDUCED

- The bearing pad surfaces generally wear down about
 1 mm per year, which is normal in a salt water environment and with the normal frictions
- When the pads wear down, this causes the panel to sit lower on the coaming table
- In turn, this increases the compression on the packing rubbers
- The rubbers will now age faster, and develop a permanent set or permanent imprint
- This reduces the compensating capacities of the rubbers and increases the risk for water ingress

- Third party work reports on the line-out of your hatch covers
- If not available, your own measurements on how much steel was added on which locations
- Measurements after repairs
- Weathertightness test result after repairs
