**ITEM: LOCATORS / STOPPERS on folding type hatch covers**

**FINDING: LONGITUDINAL LOCATOR WORN / SHOWING EXCESSIVE CLEARANCE**

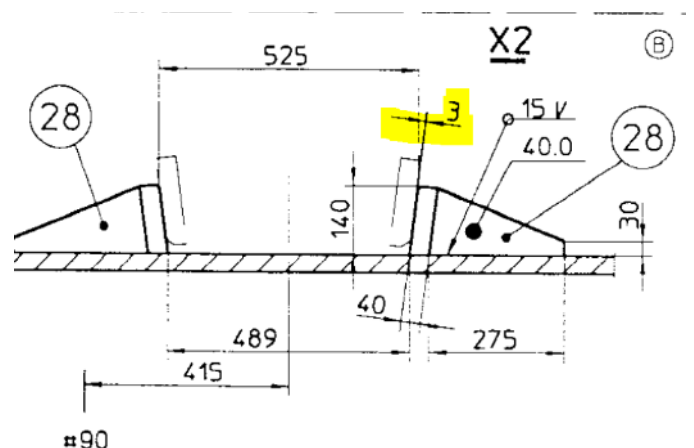
- When the locator structures are worn over time, this increases the clearance in between two panels at the meeting cross joint.
- This in turn reduces the pressure on the packing rubbers of the meeting joint, and can lead to lack of compression and leakages in those areas
- It is easier to measure the clearance on the opposite side of the locator structure instead of the steel wear-down on the pressure side which is why remarks are phrased like that

- Third party work reports on the line-out of your hatch covers
- If not available, your own measurements on how much steel was to be added on which locations
- Measurements after repair
- Weathertightness test after repair
