ITEM: BEARING PADS

FINDING: Bearing pad mating surfaces corroded/rough/scaled
Bearing pad mating surfaces not touching

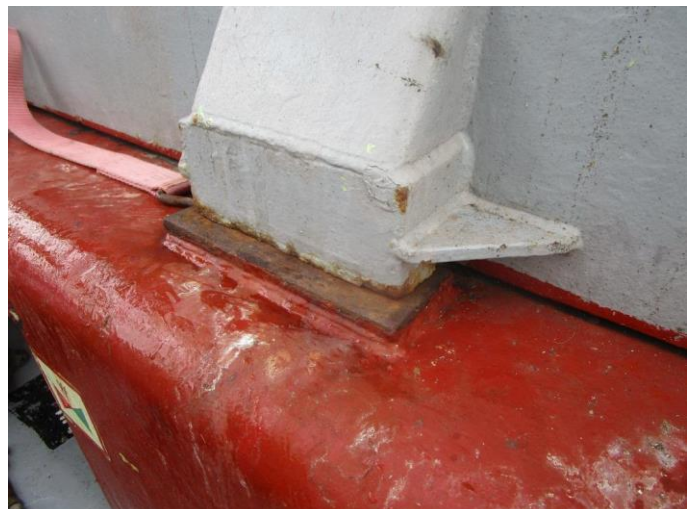
- When the surfaces which should be touching steel-to-steel are rough/corroded, this is an indication that there is no contact between the two sides of the bearing pad for a prolonged period of time
- This means that the rubbers are carrying the full weight of the panel, and will be over-compressed in time
- This is usually due to a wear-down of the bearing pad structures which happens during the life of a vessel, but could occasionally have a different root cause

- Third party work reports on the line-out of your hatch covers
- If not available, your own measurements on how much steel was added on which locations
- Measurements after repairs
- Weathertightness test result after repairs
