ITEM: HATCH COVER MANUAL

FINDING: Hatch cover manual not on board / incomplete

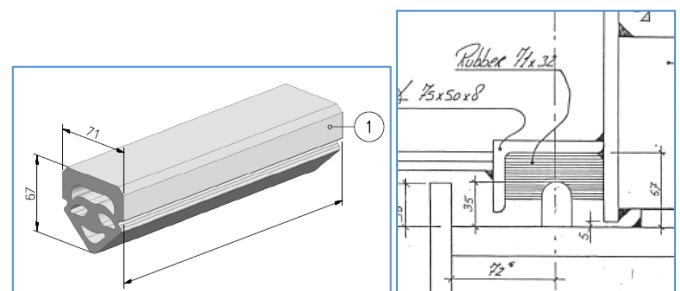
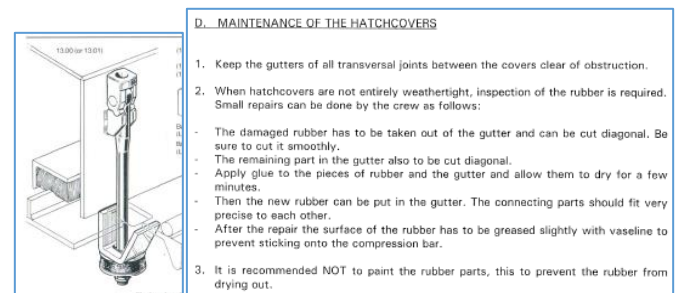
Without the hatch cover manual, the hatch cover's condition cannot be properly monitored / maintained during trading, nor be properly repaired during off-hire periods such as dry docking.

- Attempt to locate hatch cover manual on board, or request a copy from Class, from shipyard, from sister vessels, etc.
- Implementation in PMS on board
